05 - STRUCTURES INDEX OF DRAWINGS

SUBSTRUCTURE CONCRETE REPAIRS IN DISTRICT 2

SUBSET COVER SHEET INDEX OF DRAWINGS-1

172-417
DRAWING NO.
S-01

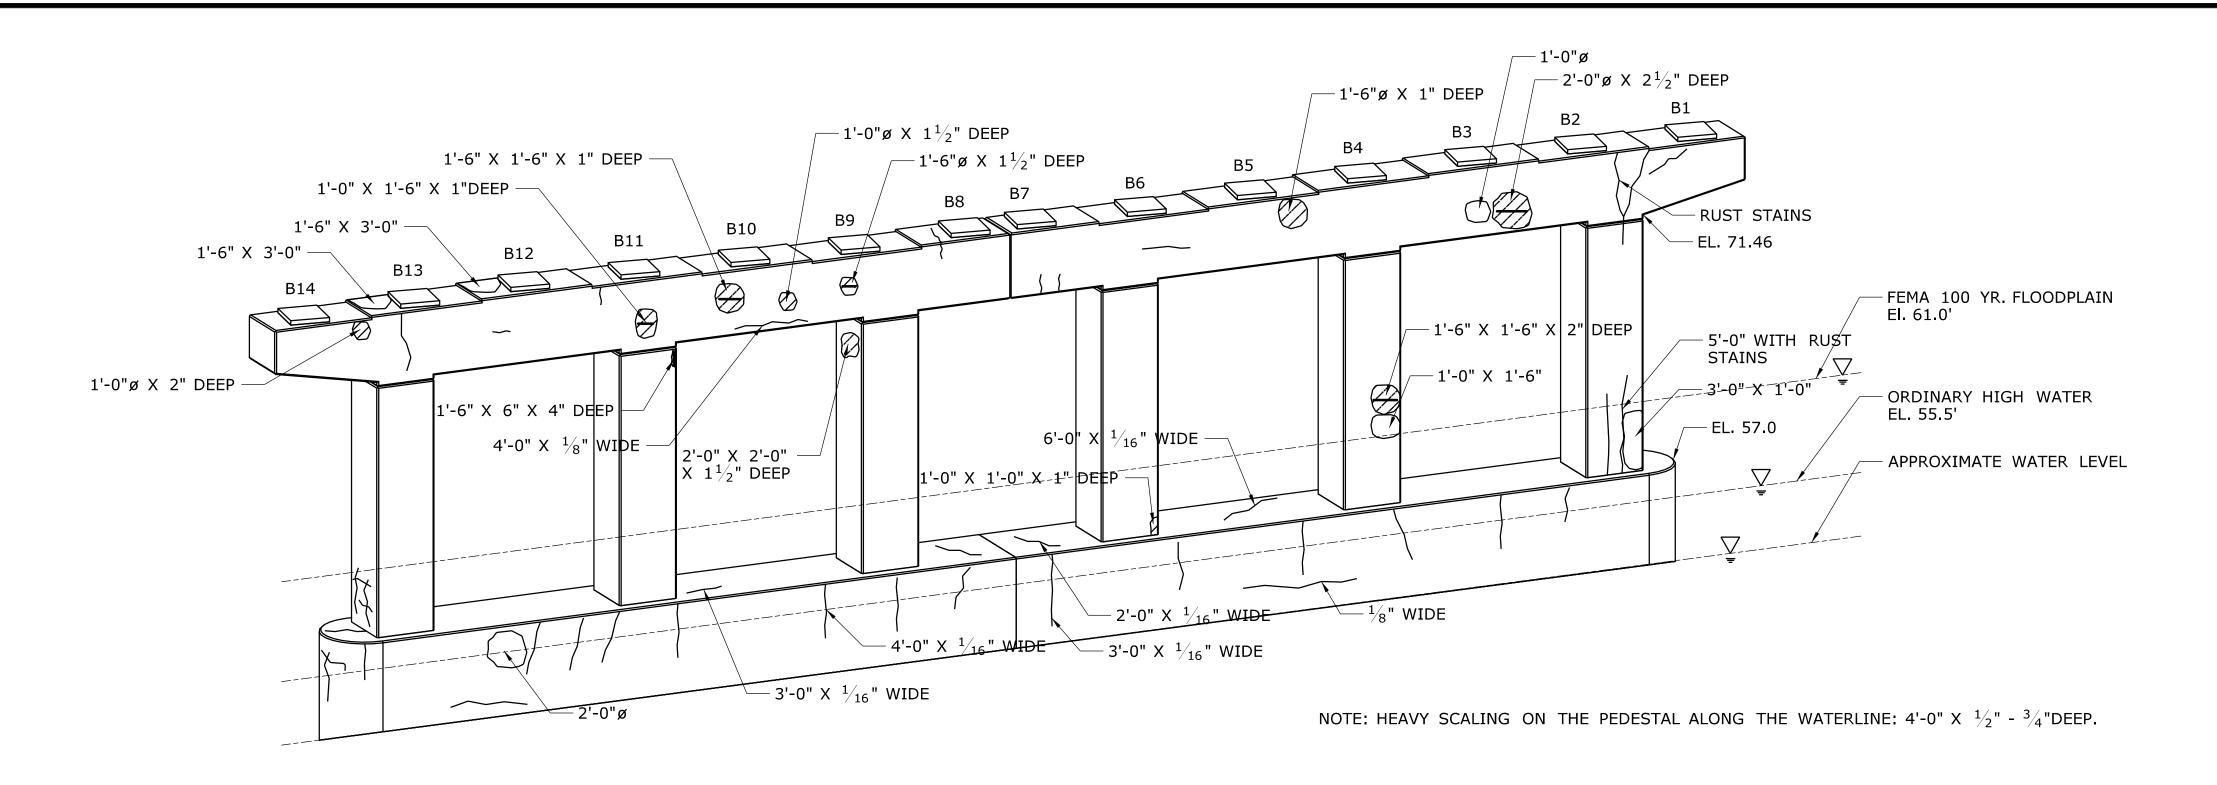
PIER 7 - EAST ELEVATION

THE SUBSTRUCTURE DETERIORATION AND REPAIR DIMENSIONS SHOWN ARE BASED ON LIMITED FIELD OBSERVATIONS AND BRIDGE SAFETY

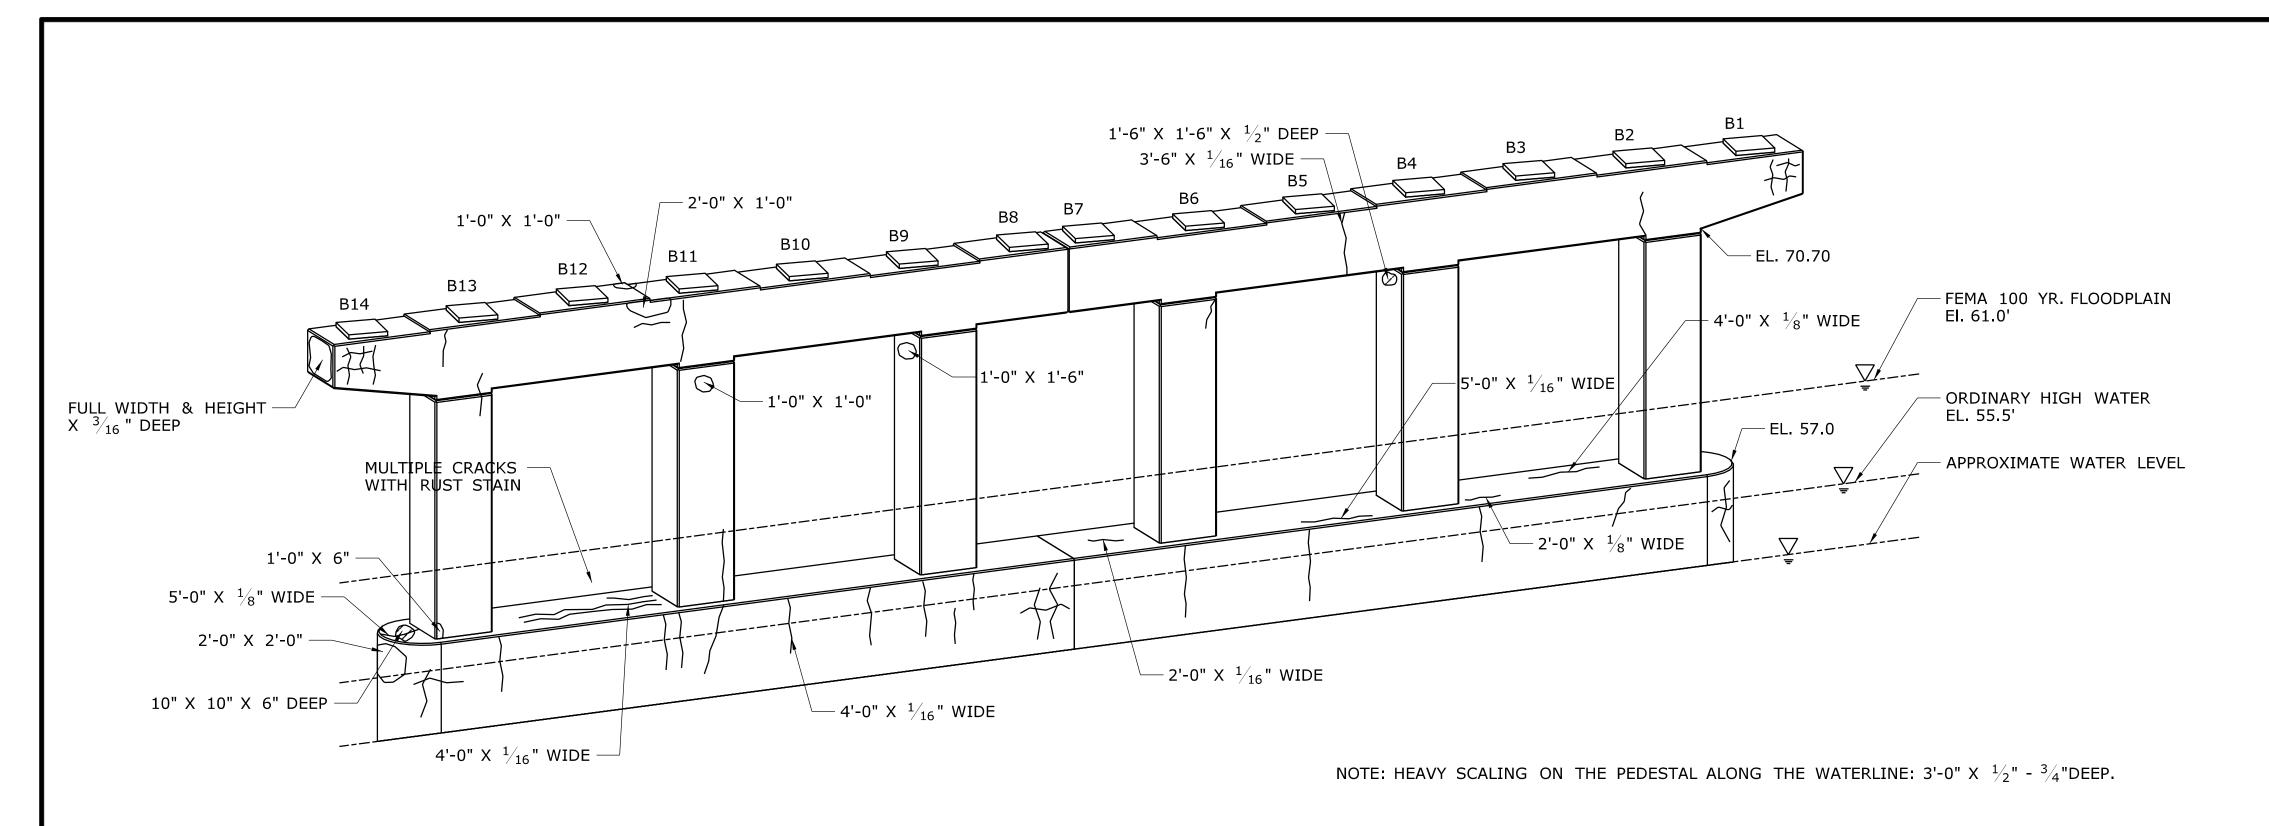
PIER 8 - EAST ELEVATION

- 3. THE CONTRACTOR SHALL NOT PERFORM ANY REPAIR WORK WITHOUT PRIOR APPROVAL FROM THE ENGINEER.
- 4. SPALLS, HOLLOW AND SCALE AREAS SHALL BE REPAIRED IN ACCORDANCE WITH "SHALLOW PATCH REPAIR DETAIL" OR "DEEP PATCH REPAIR DETAIL" SHOWN ON DWG. NO. S-05.

- 5. MAXIMUM 15 LB PNEUMATIC HAMMER TO BE USED ADJACENT TO EXISTING REINFORCING TO REMAIN.
- 6. ALL REPAIRS ABOVE THE ORDINARY HIGH WATER ELEVATION.

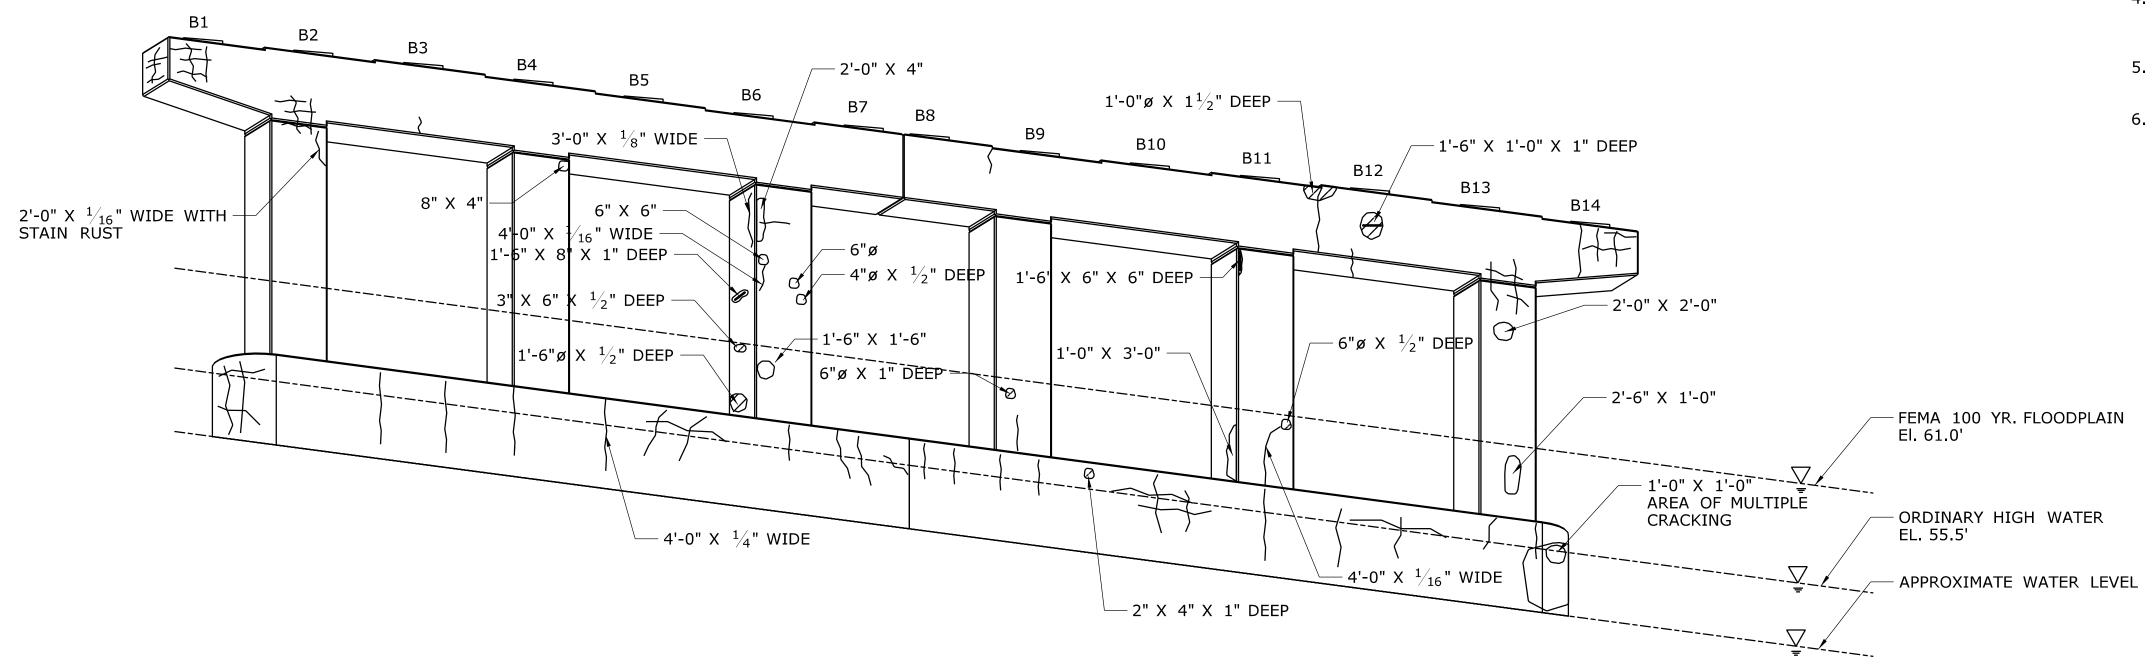
PIER 8 - WEST ELEVATION

NOTE: HEAVY SCALING ON THE PEDESTAL ALONG THE WATERLINE: 3'-0" X $\frac{1}{2}$ " - $\frac{3}{4}$ "DEEP.

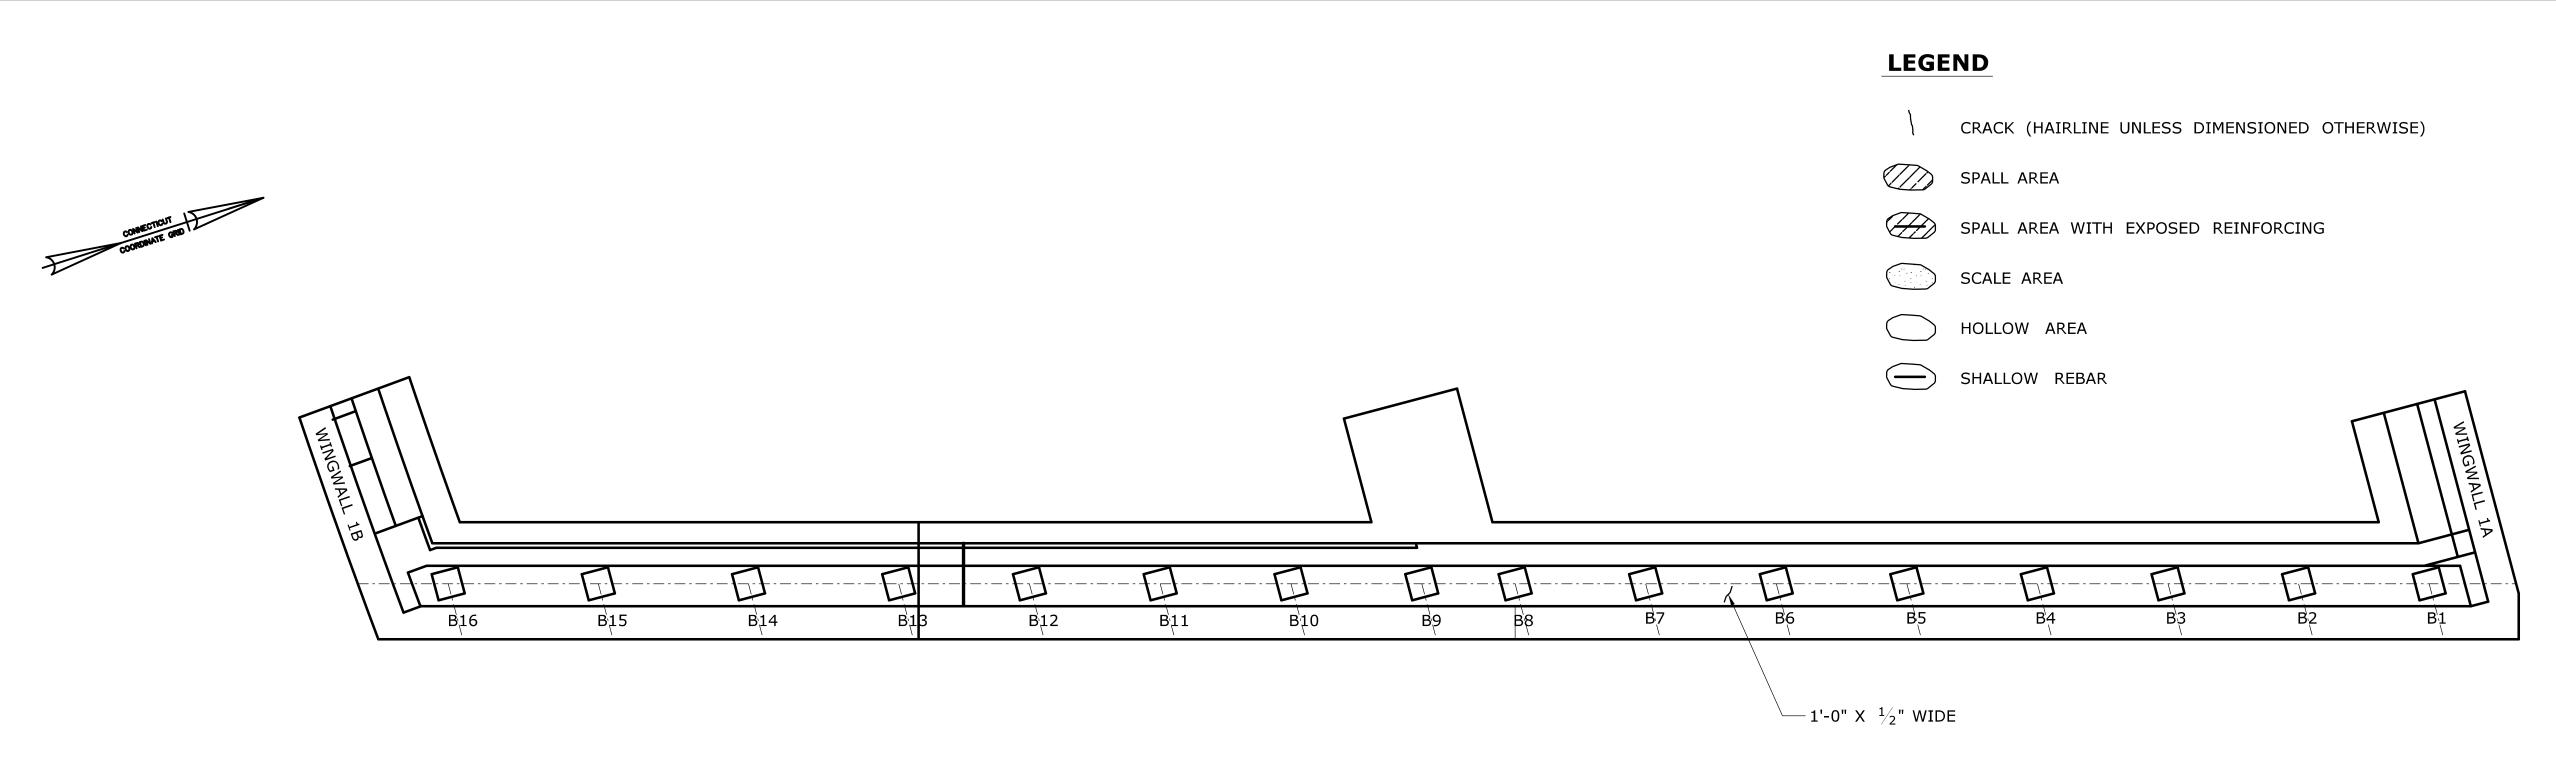
PLAN

- 1. THE SUBSTRUCTURE DETERIORATION AND REPAIR DIMENSIONS SHOWN ARE BASED ON LIMITED FIELD OBSERVATIONS AND BRIDGE SAFETY INSPECTION REPORT (10/5/2009 AND 9/8/2009). THE INFORMATION IS INTENDED TO BE USED AS A GUIDE AND DOES NOT NECESSARILY REFLECT THE CURRENT CONDITION OF THE STRUCTURE. THE EXACT LOCATION AND LIMITS OF DETERIORATED CONCRETE TO BE REPAIRED SHALL BE DETERMINED BY THE ENGINEER DURING CONSTRUCTION.
- 2. THE CONTRACTOR SHALL PROVIDE SAFE ACCESS FOR THE ENGINEER TO DELINEATE AND REVIEW THE REPAIR WORK. THE COST OF PROVIDING ACCESS SHALL BE INCLUDED IN THE COST OF APPROPRIATE REPAIR ITEMS.
- 3. THE CONTRACTOR SHALL NOT PERFORM ANY REPAIR WORK WITHOUT PRIOR APPROVAL FROM THE ENGINEER.

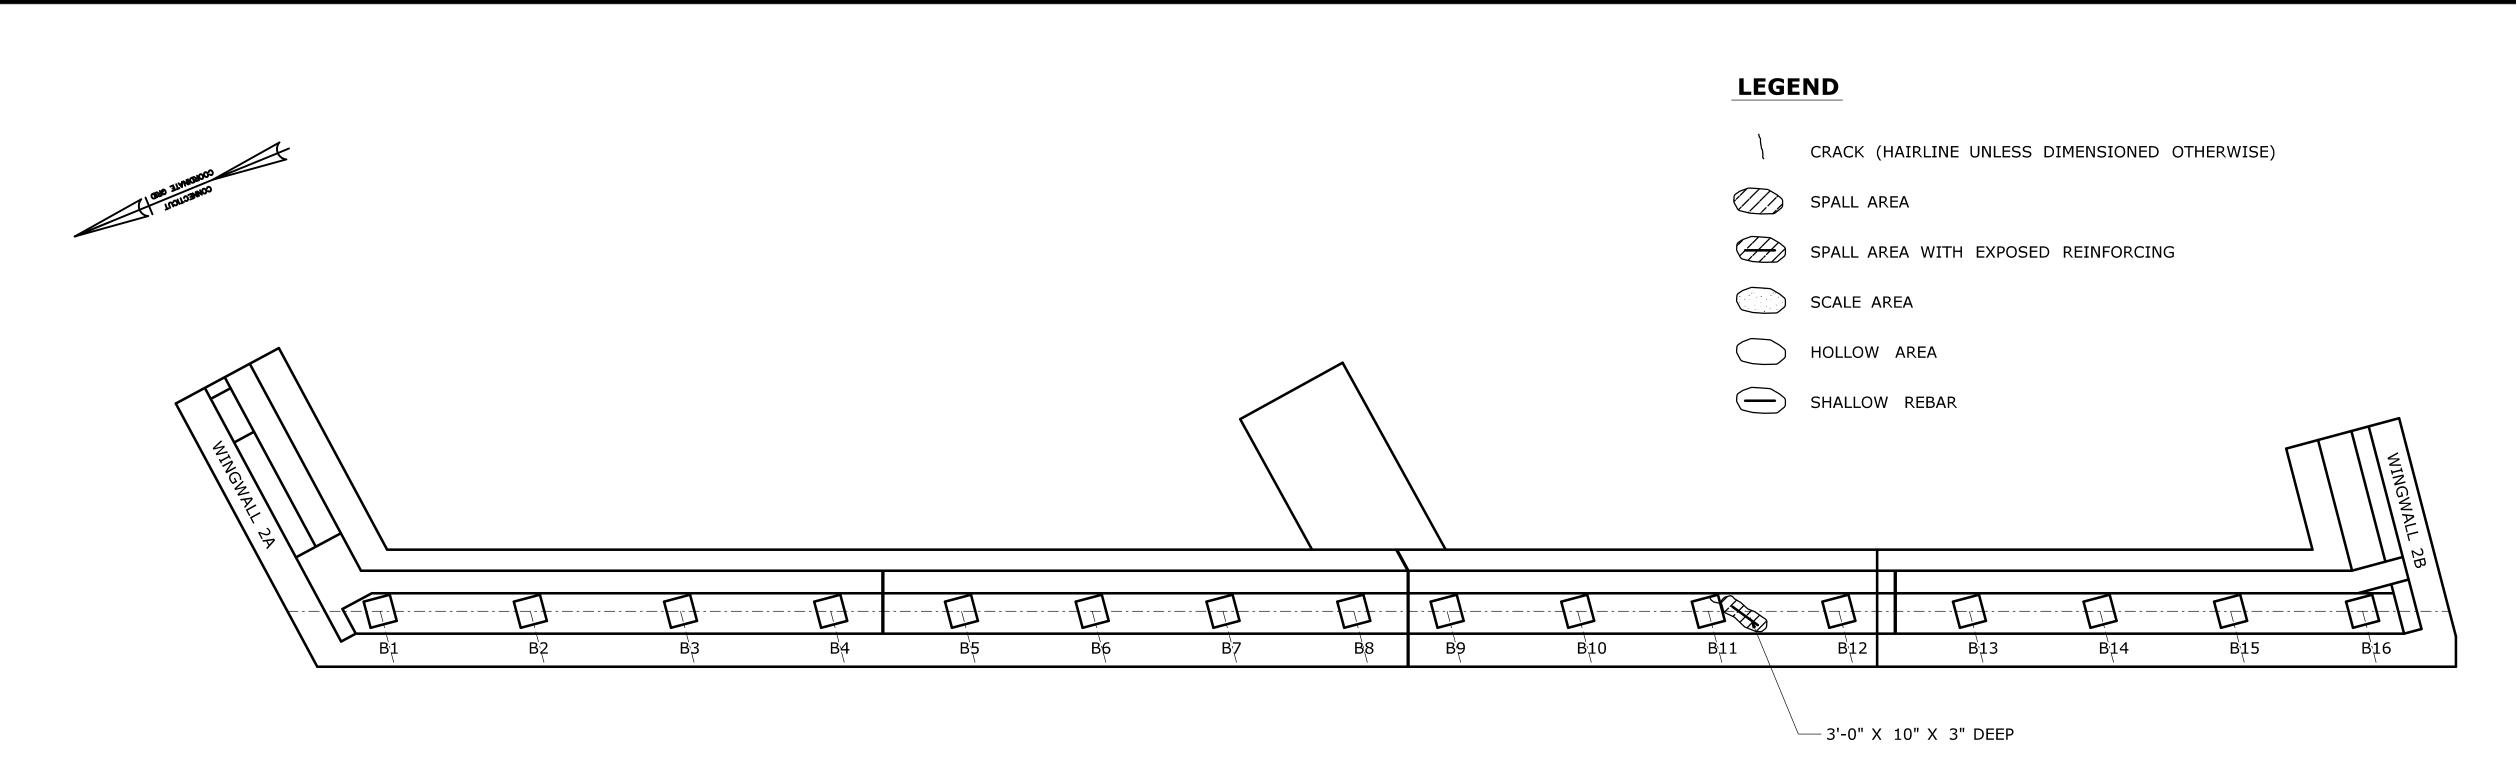
PLAN

- 1. THE SUBSTRUCTURE DETERIORATION AND REPAIR DIMENSIONS SHOWN ARE BASED ON LIMITED FIELD OBSERVATIONS AND BRIDGE SAFETY INSPECTION REPORT (10/5/2009 AND 9/8/2009). THE INFORMATION IS INTENDED TO BE USED AS A GUIDE AND DOES NOT NECESSARILY REFLECT THE CURRENT CONDITION OF THE STRUCTURE. THE EXACT LOCATION AND LIMITS OF DETERIORATED CONCRETE TO BE REPAIRED SHALL BE DETERMINED BY THE ENGINEER DURING CONSTRUCTION.

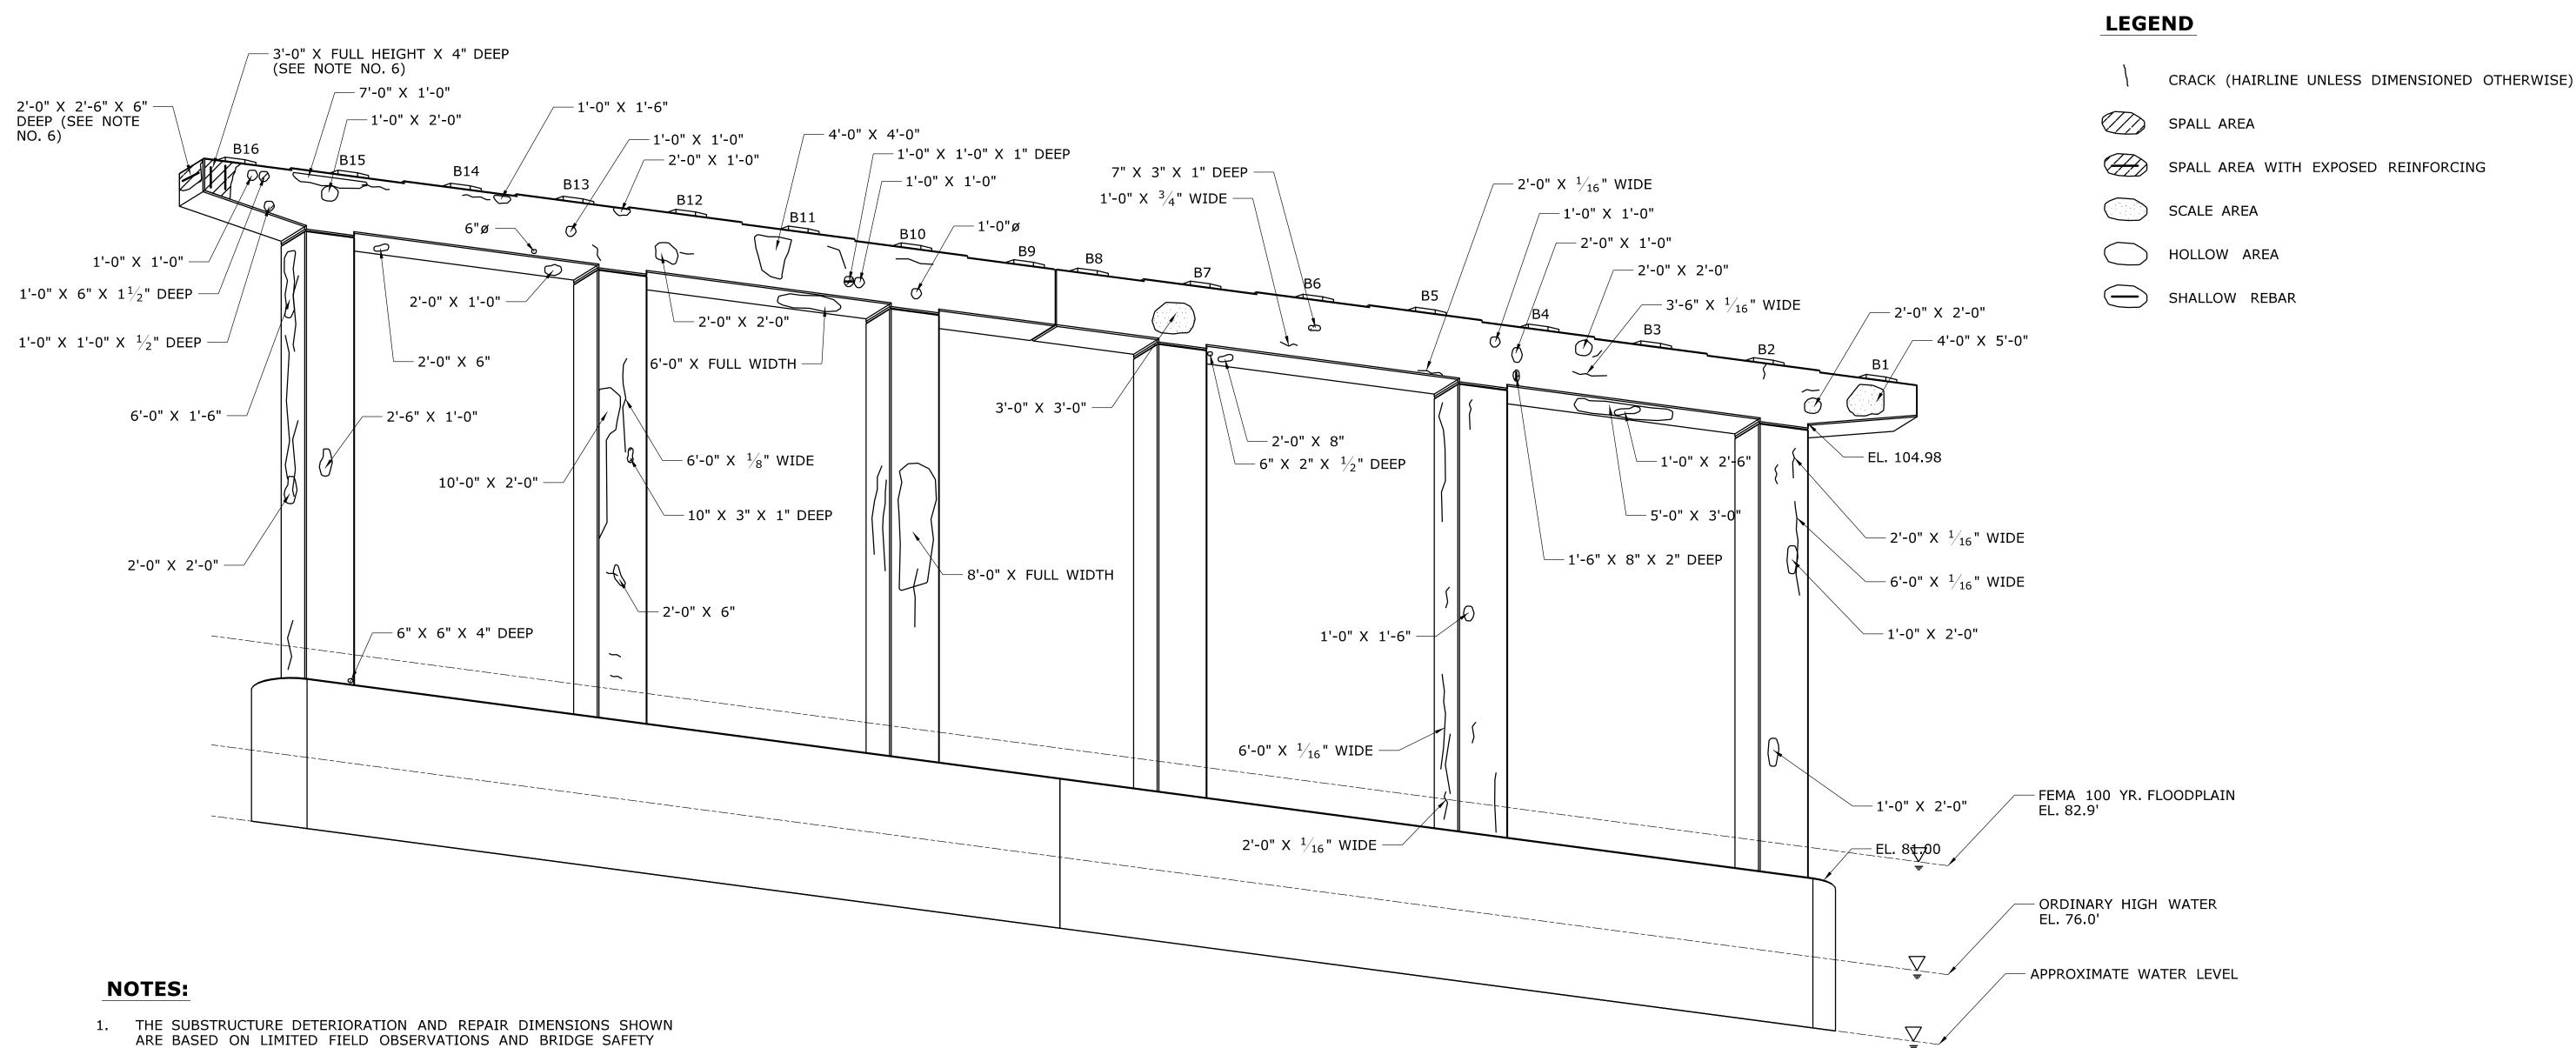
PTFR	3	_	FΔST	ELEVATION
			LAJI	FFFAVITOIA

- 5. MAXIMUM 15 LB PNEUMATIC HAMMER TO BE USED ADJACENT TO EXISTING REINFORCING TO REMAIN.
- 6. FOR REPAIRS AT SOUTH CANTILEVER OF PIER, SEE DWG. NO. S-61.

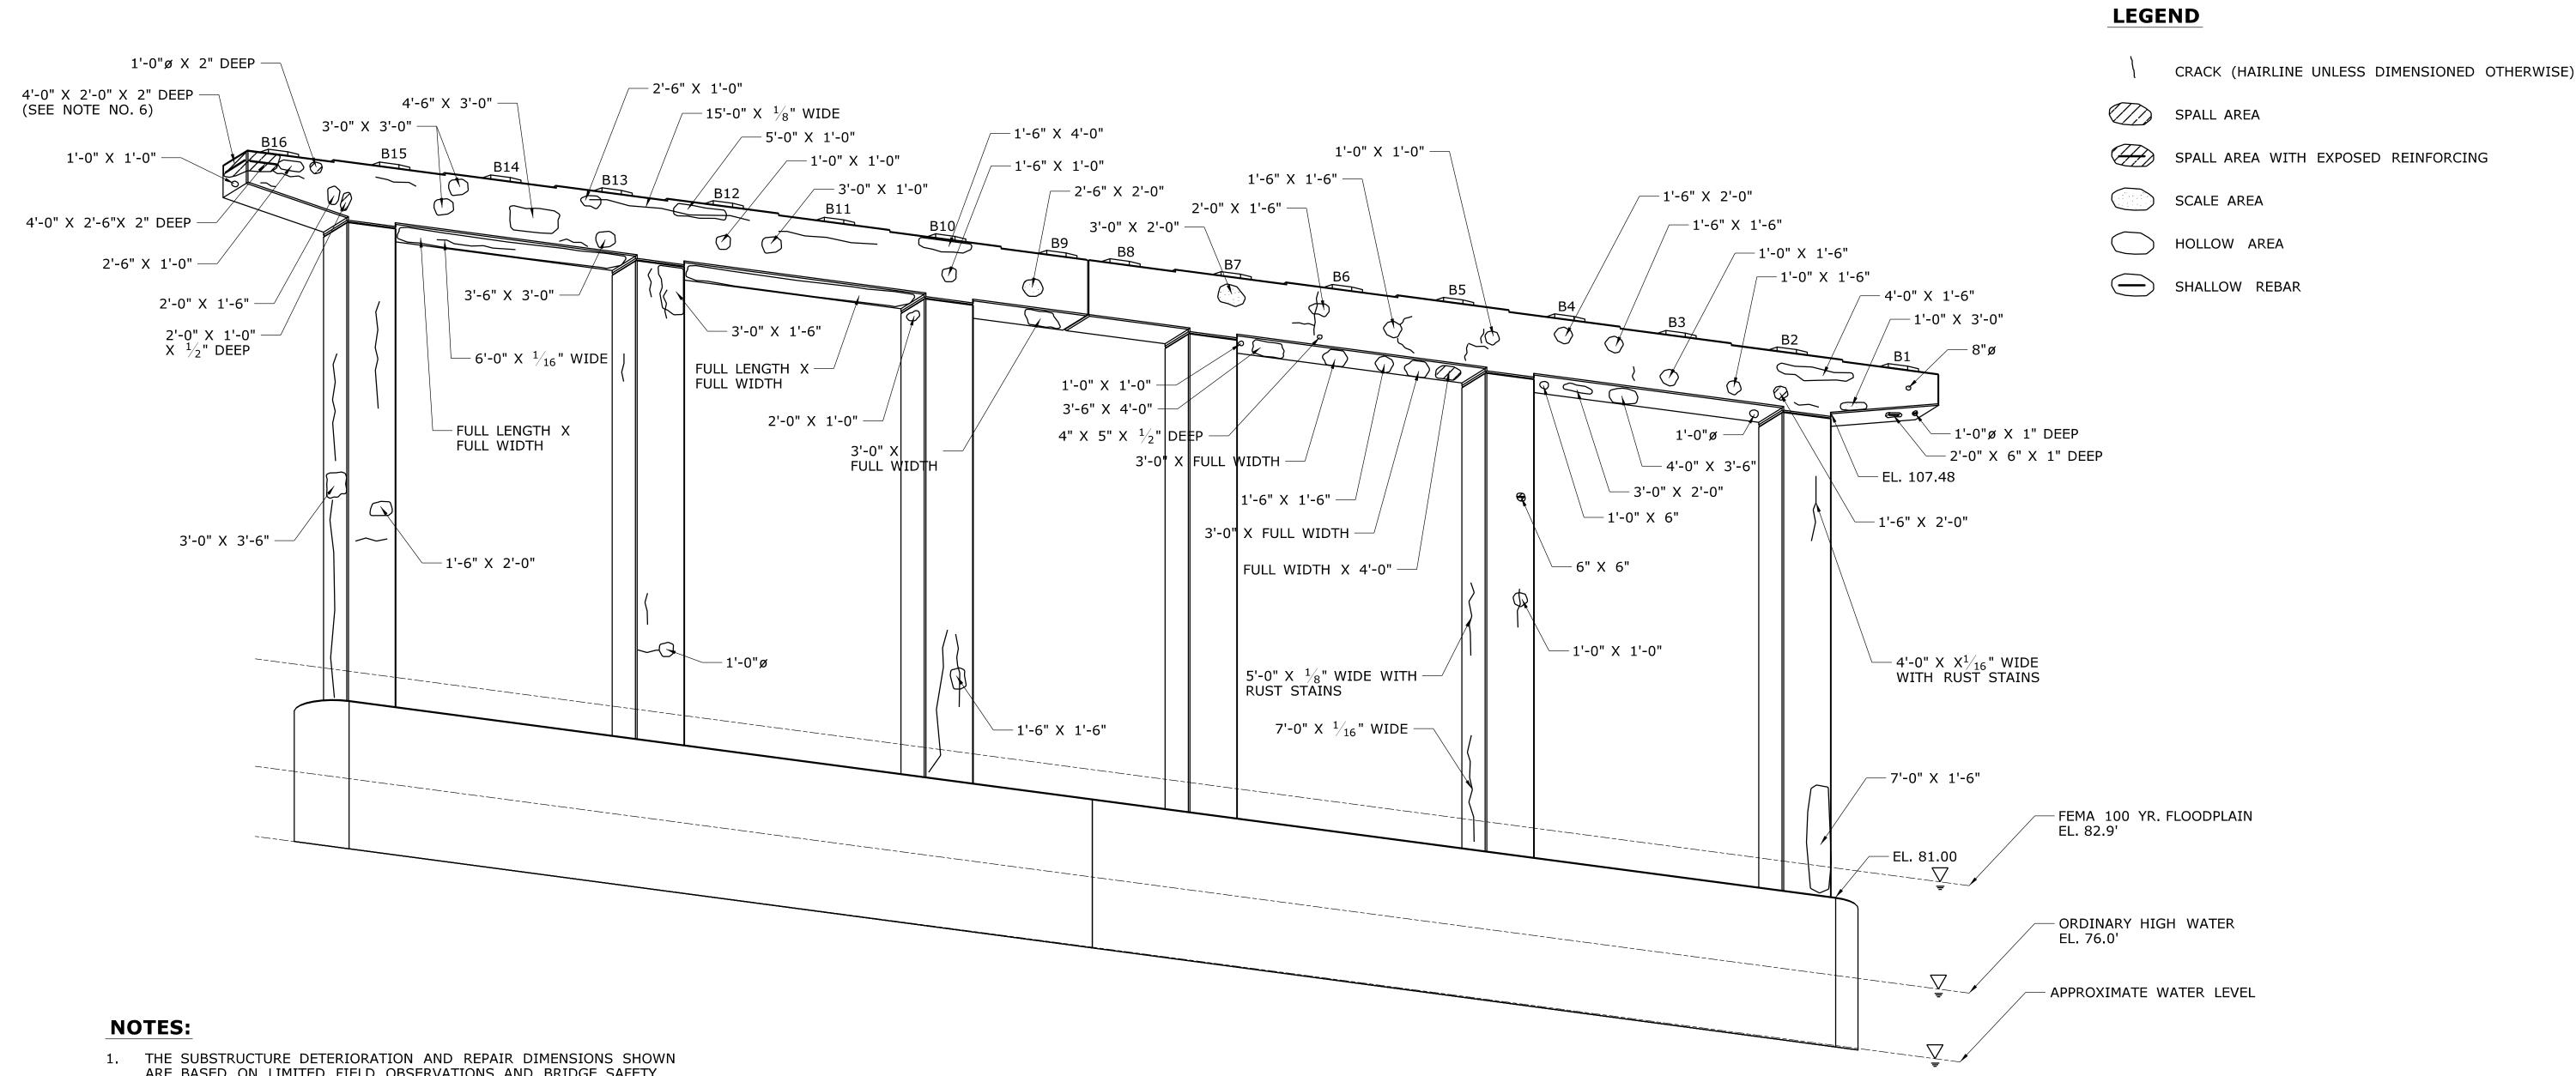
PIER 5 - EAST	ELEVATION
---------------	------------------

- 5. MAXIMUM 15 LB PNEUMATIC HAMMER TO BE USED ADJACENT TO EXISTING REINFORCING TO REMAIN.
- 6. FOR REPAIRS AT SOUTH CANTILEVER OF PIER, SEE DWG. NO. S-61.

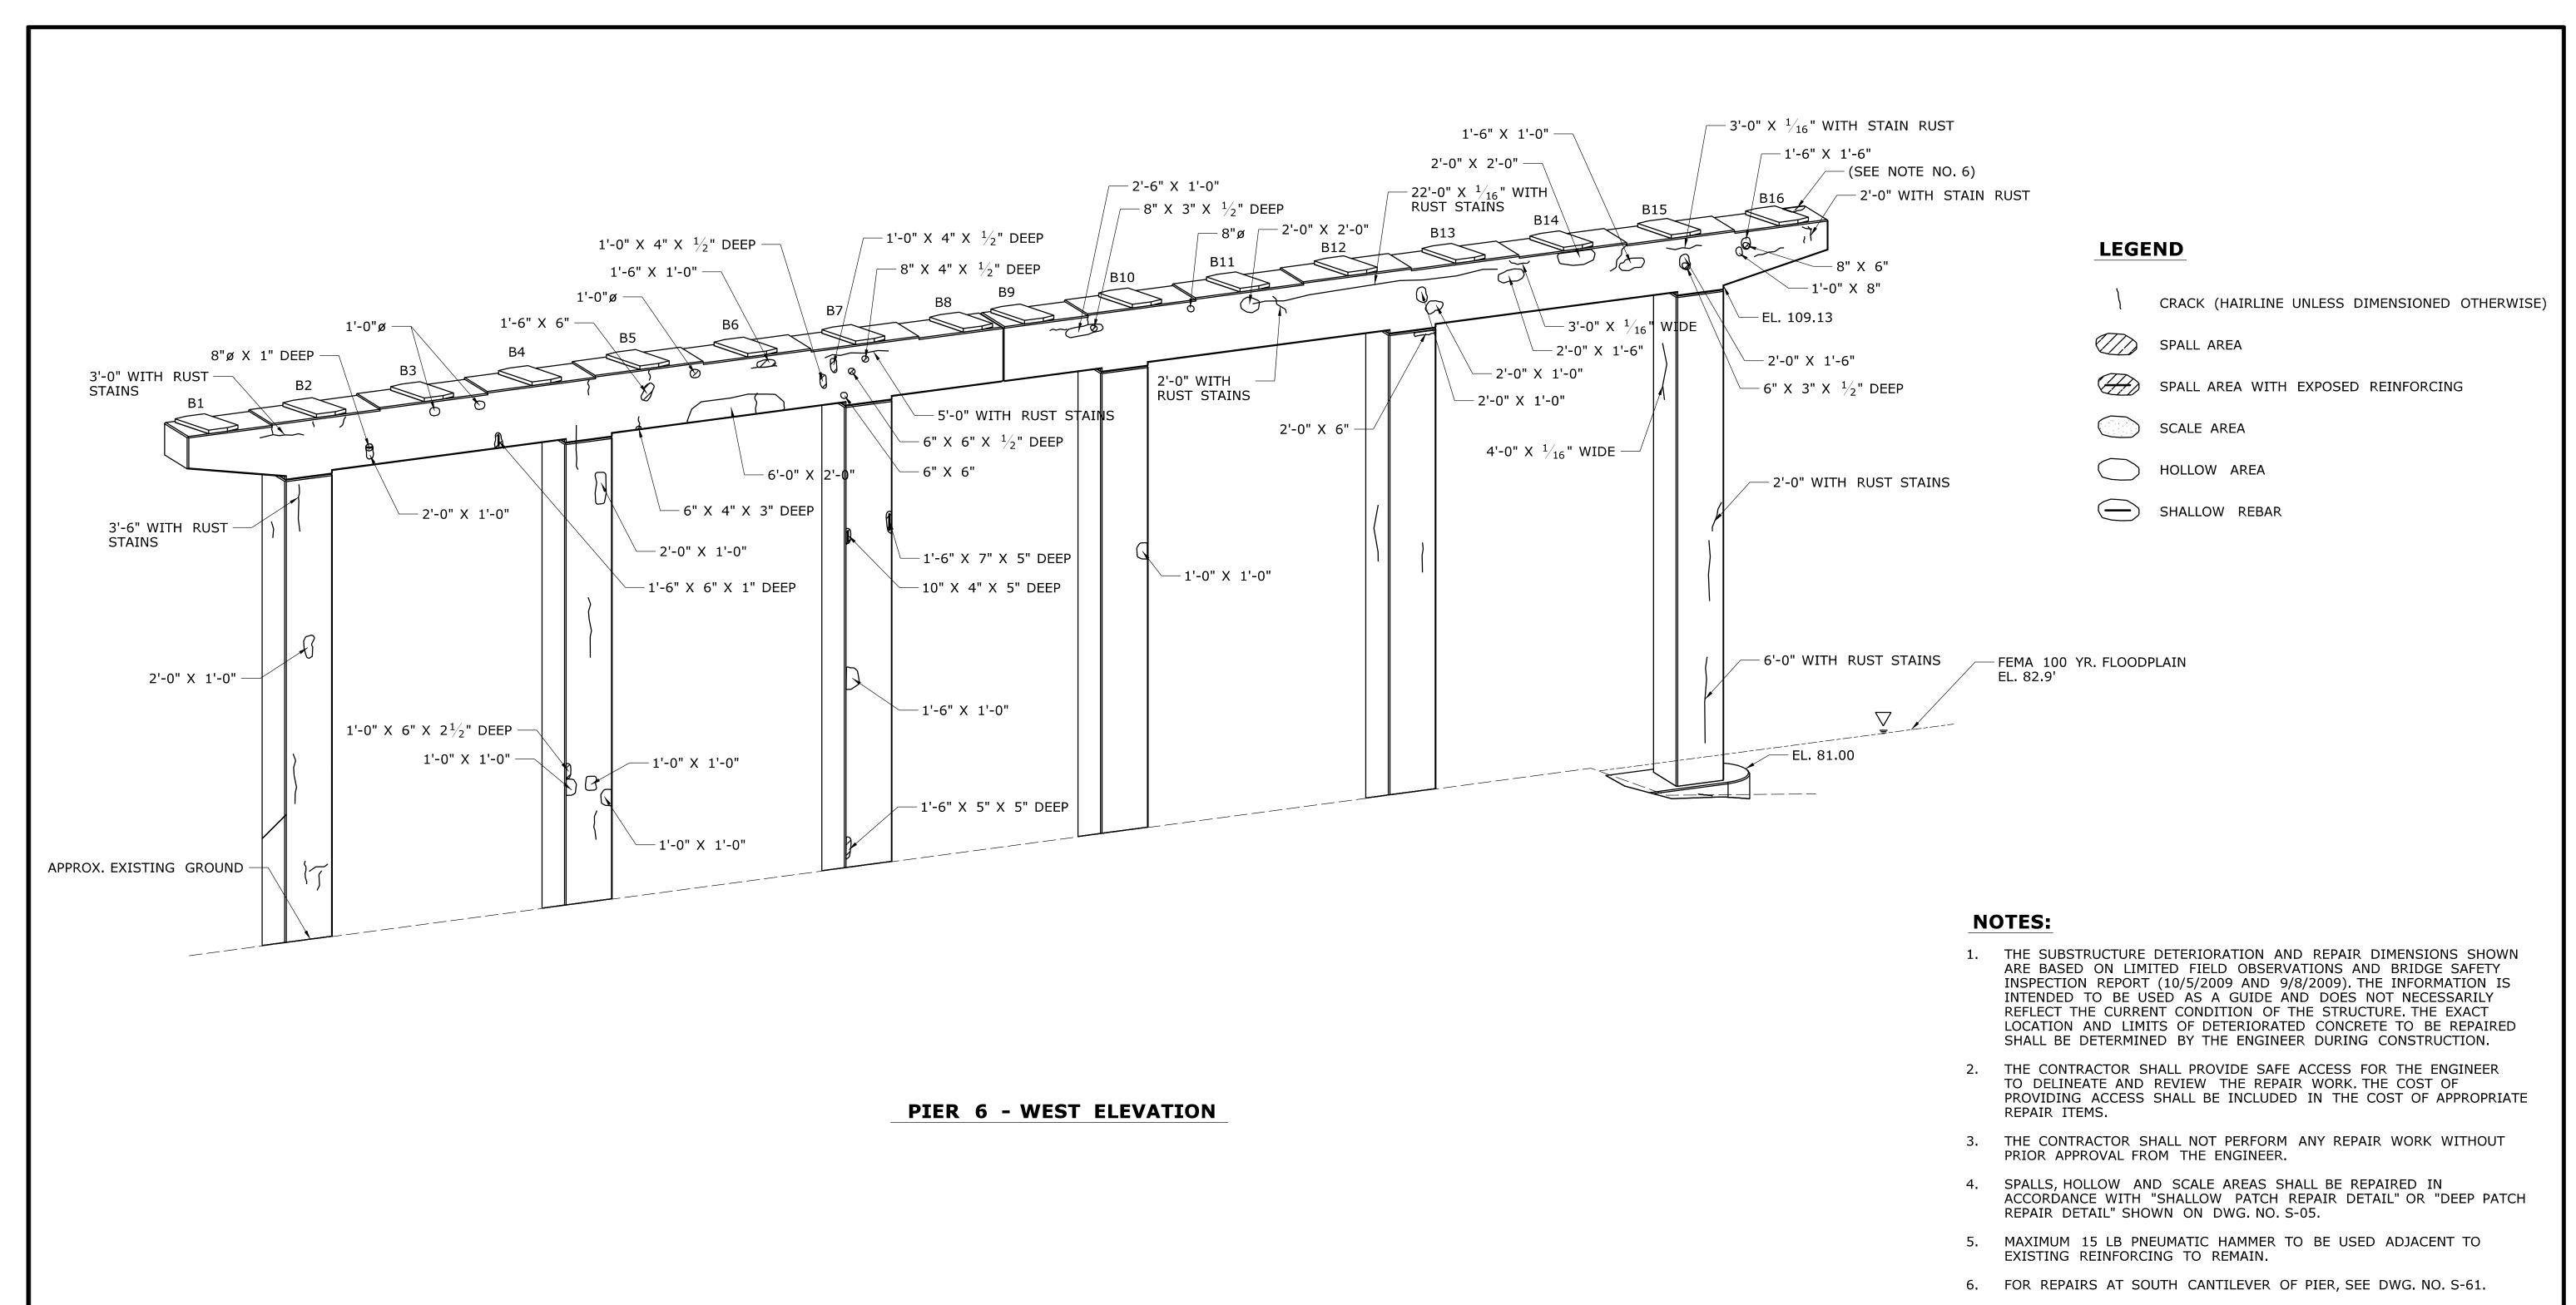
7. EXISTING CATWALK TO BE REMOVED NOT SHOWN (SEE SPECIAL PROVISION "REMOVAL OF GRID DECK AND STRINGERS").

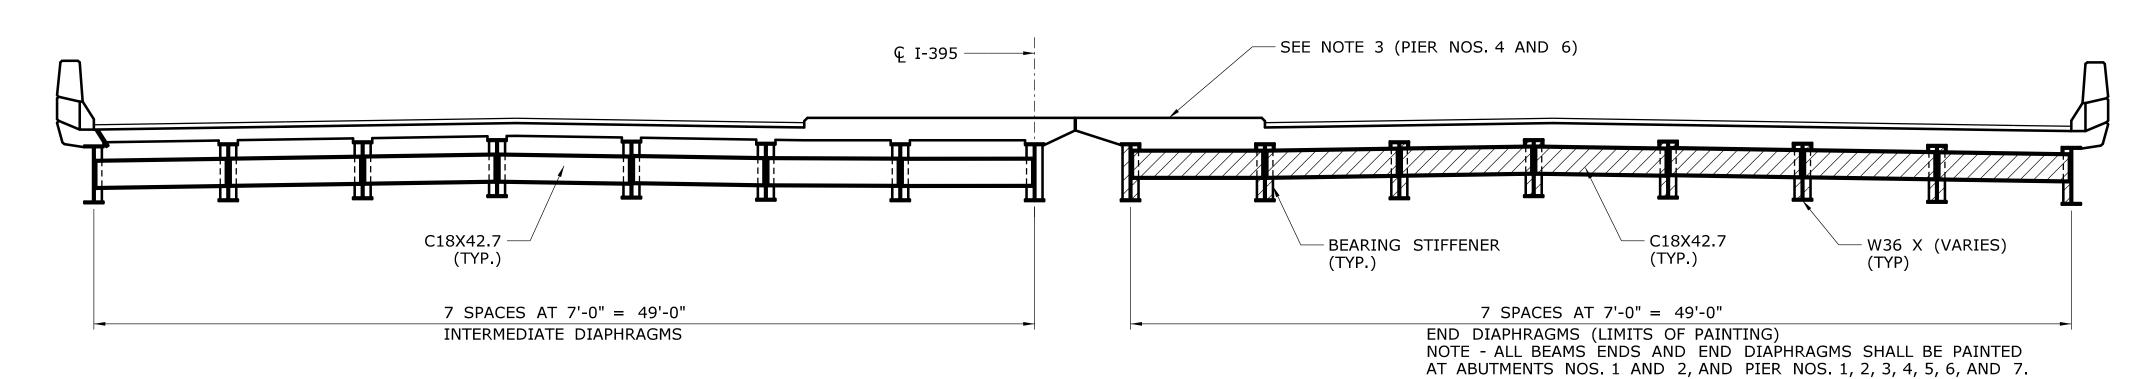
TYPICAL BRIDGE SECTION

SCALE: 1" = 5'

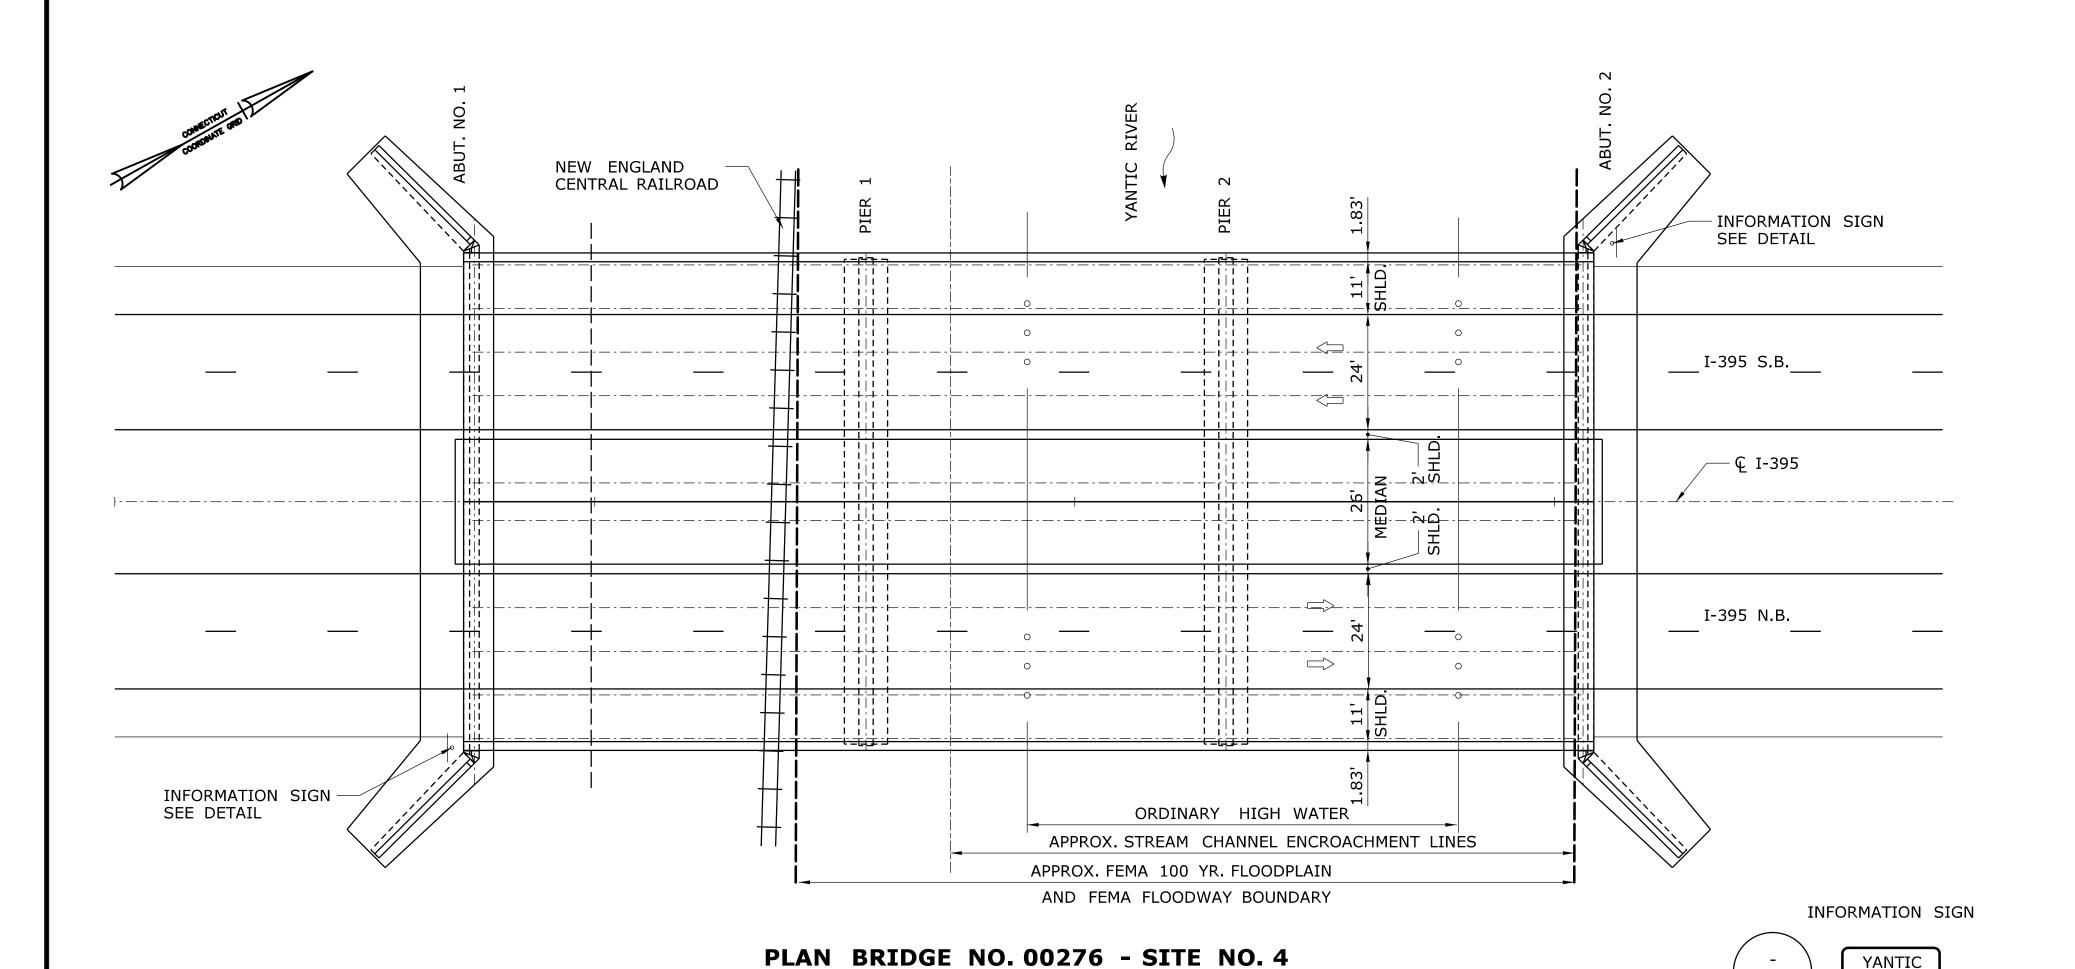
81.583' 75' 74.417' SPAN 1 SPAN 2 SPAN 3 CLEAN AND PAINT DETERIORATED BEAM ENDS (TYP.) FEMA 100 YR. ₽ RR ORDINARY HIGH FLOODPLAIN WATER EL. 85.5' EL. 92.5' REPAIR DETERIORATED RANGE OF SUSPENDED TEMPORARY DEBRIS AREAS OF SUBSTRUCTURE (TYP.) SHIELD/WORK PLATFORM, TYPICAL EVERY PIER

1. VERTICAL DATUM BASED ON NGVD 1929. 2. ALL REPAIRS SHALL BE ABOVE THE ORDINARY HIGH WATER ELEVATION.

1. REPAIR DETERIORATED AREAS OF SUBSTRUCTURE. 2. CLEAN AND PAINT BEAM ENDS AT BOTH PIERS.

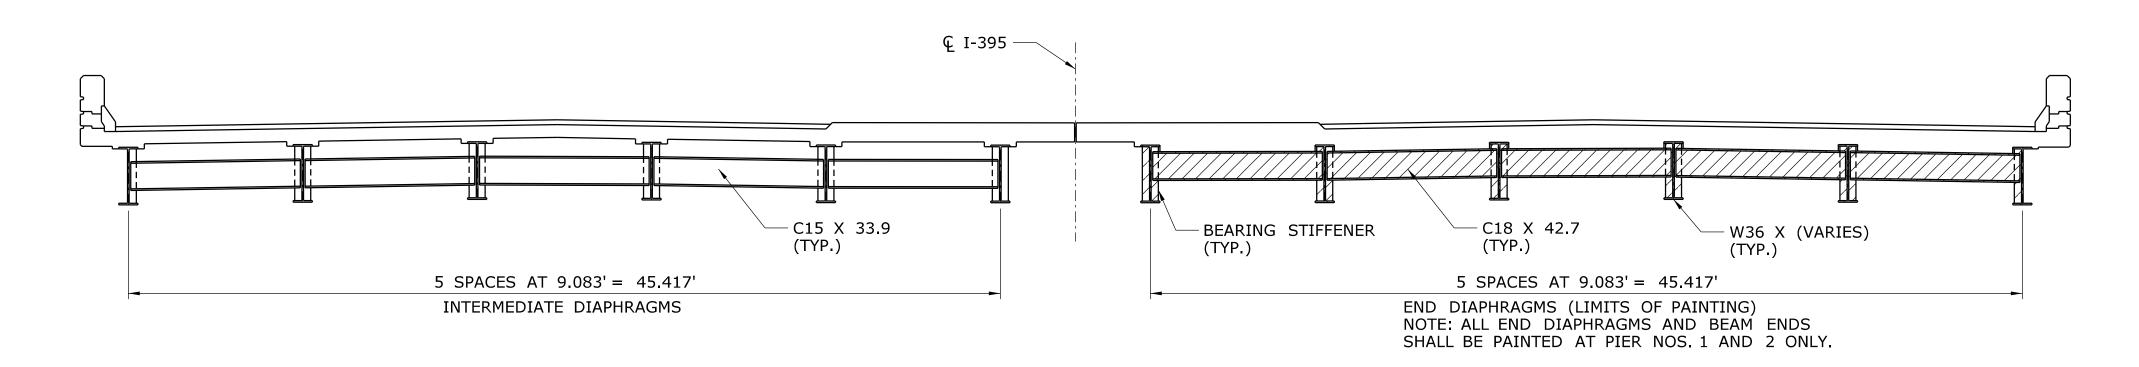
TYPICAL BRIDGE SECTION

SCALE: 1" = 5'

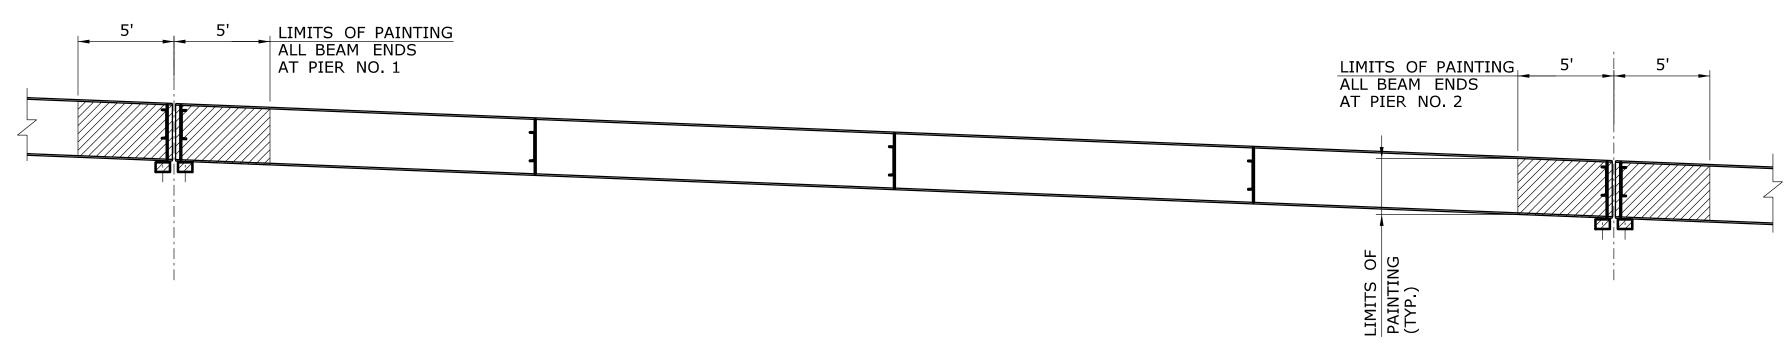
TYPICAL BEAM ELEVATION

SCALE: 1" = 5'

- 1. THE PAINTING LIMITS ARE FROM THE END OF THE BEAM TO THE DISTANCE SPECIFIED ON THIS SHEET AND SHALL INCLUDE ANY EXPOSED SURFACES OF ALL STEEL ELEMENTS INCLUDING THE BEAMS, BEARING STIFFENERS, END DIAPHRAGMS AND ALL ELEMENTS OF STEEL BEARINGS.
- 2. THE COLOR OF THE TOP COAT ON THE STRUCTURAL STEEL SHALL MATCH EXISTING AS CLOSELY AS PRACTICABLE.
- 3. PAINT REMOVAL AND PAINTING OF THE DELINEATED AREAS SHALL BE INCLUDED UNDER THE PAY ITEM "LOCALIZED PAINT REMOVAL AND FIELD PAINTING OF BEAM ENDS (SITE NO. 4)".
